AFRL-ML-WP-TR-2001-4020

**LIFE PREDICTION METHODOLOGIES FOR
AEROSPACE MATERIALS**

INTERIM REPORT FOR PERIOD 25 MAY 1999 - 24 MAY 2000

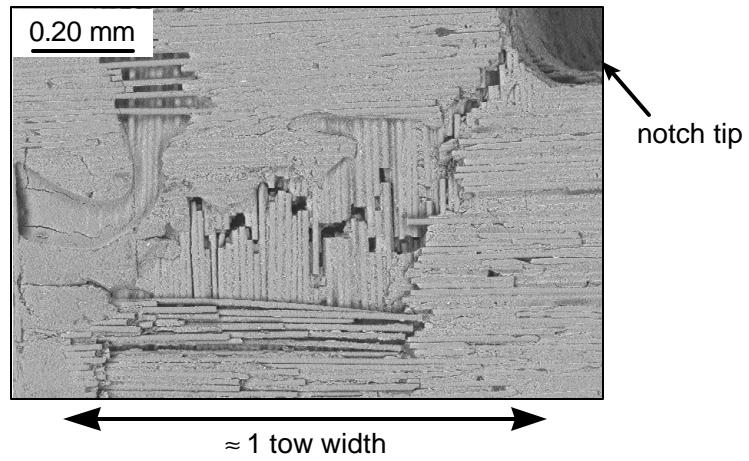
Figure 10. Notch tip region of 950°C specimen shown in Fig. 6c, after removing the top matrix layer and some 90° fibers. Failed 0° fibers were identified along the length of the dominant crack.

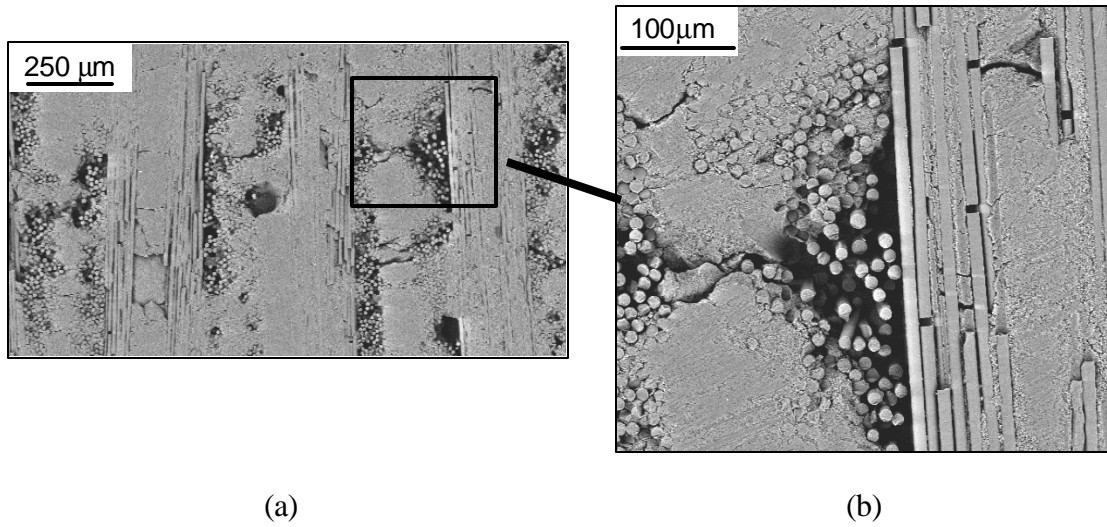
Figure 8. Higher magnification micrographs of post peak fracture specimen (Fig. 7(d), $\sigma_n = 150$ MPa) (a) cross-section view of notch tip region (b) higher magnification of selected region on left with 0° fiber breaks.
